**BioMax Environmental**

**Post Mitigation Assessment Report**  
**Department of General Services Board of Equalization Building**  
**450 N. Street - 22<sup>nd</sup> Floor East Containment Area**  
**Sacramento, California**

BOE Building 22<sup>nd</sup> Floor East Clearance  
Sacramento, CA

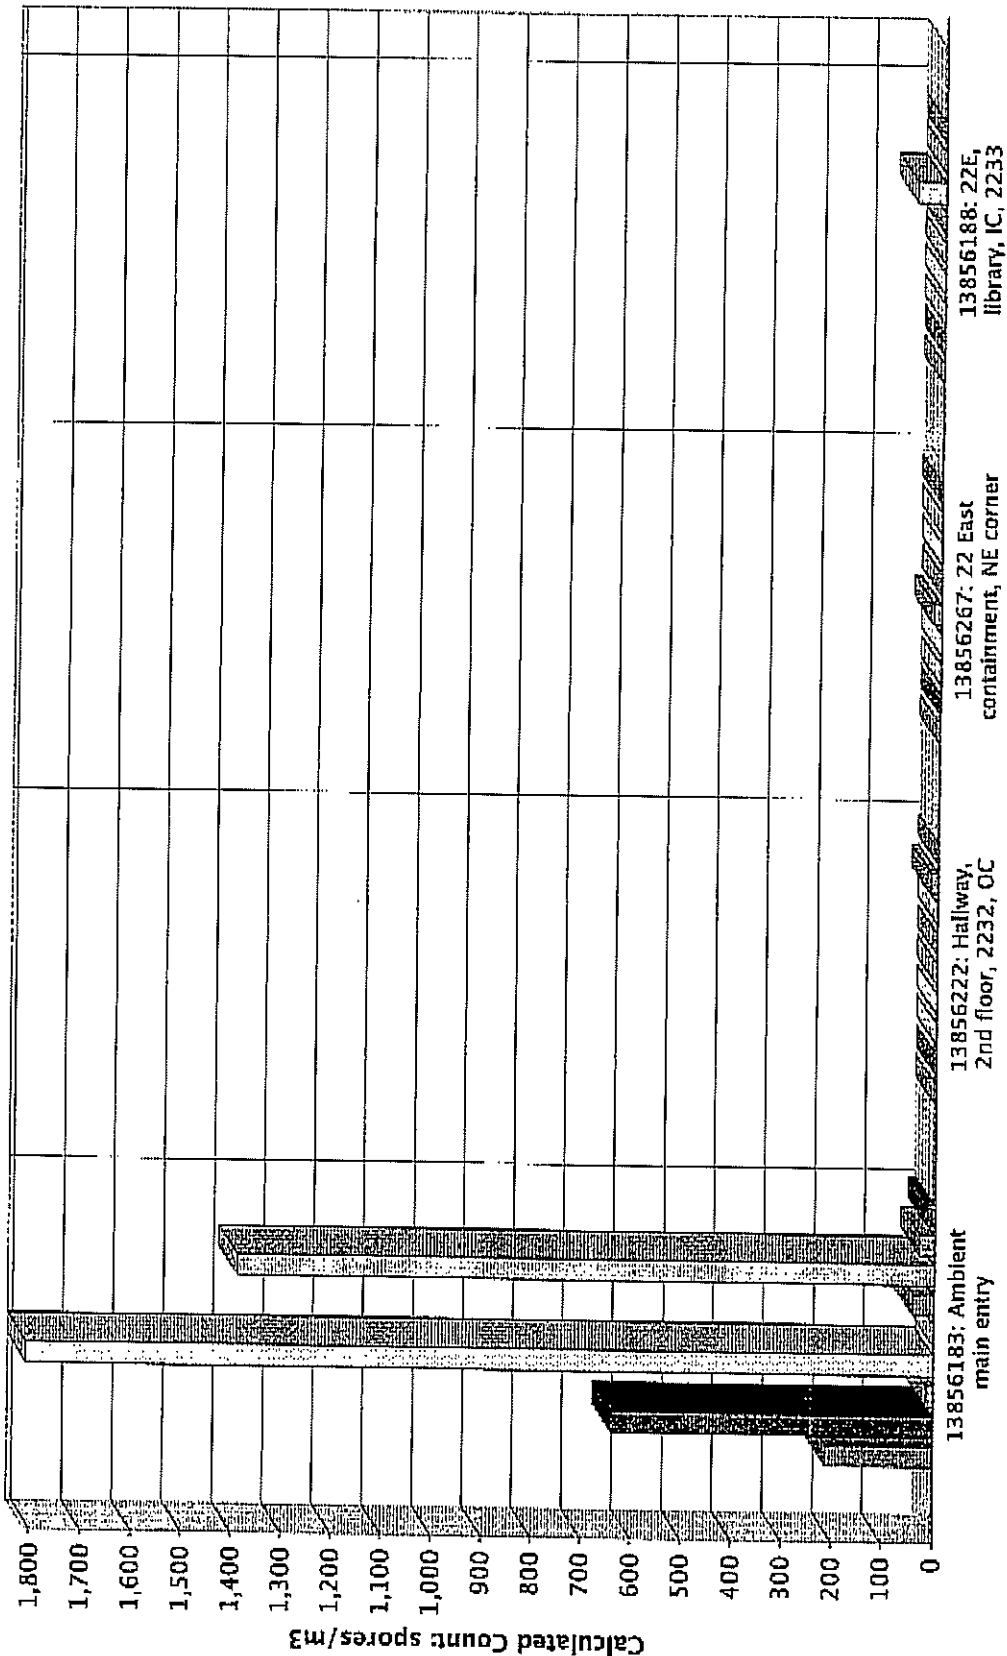
SPORE TRAP REPORT: NON-VIABLE METHODOLOGY

Ascospores Basidiospores Chaetomium Cladosporium Epicoccum Other brown Penicillium/Aspergillus types  
Smuts, Periconia, Myxomycetes Torula

Note: Graphical output may understate the importance of certain "marker" genera.

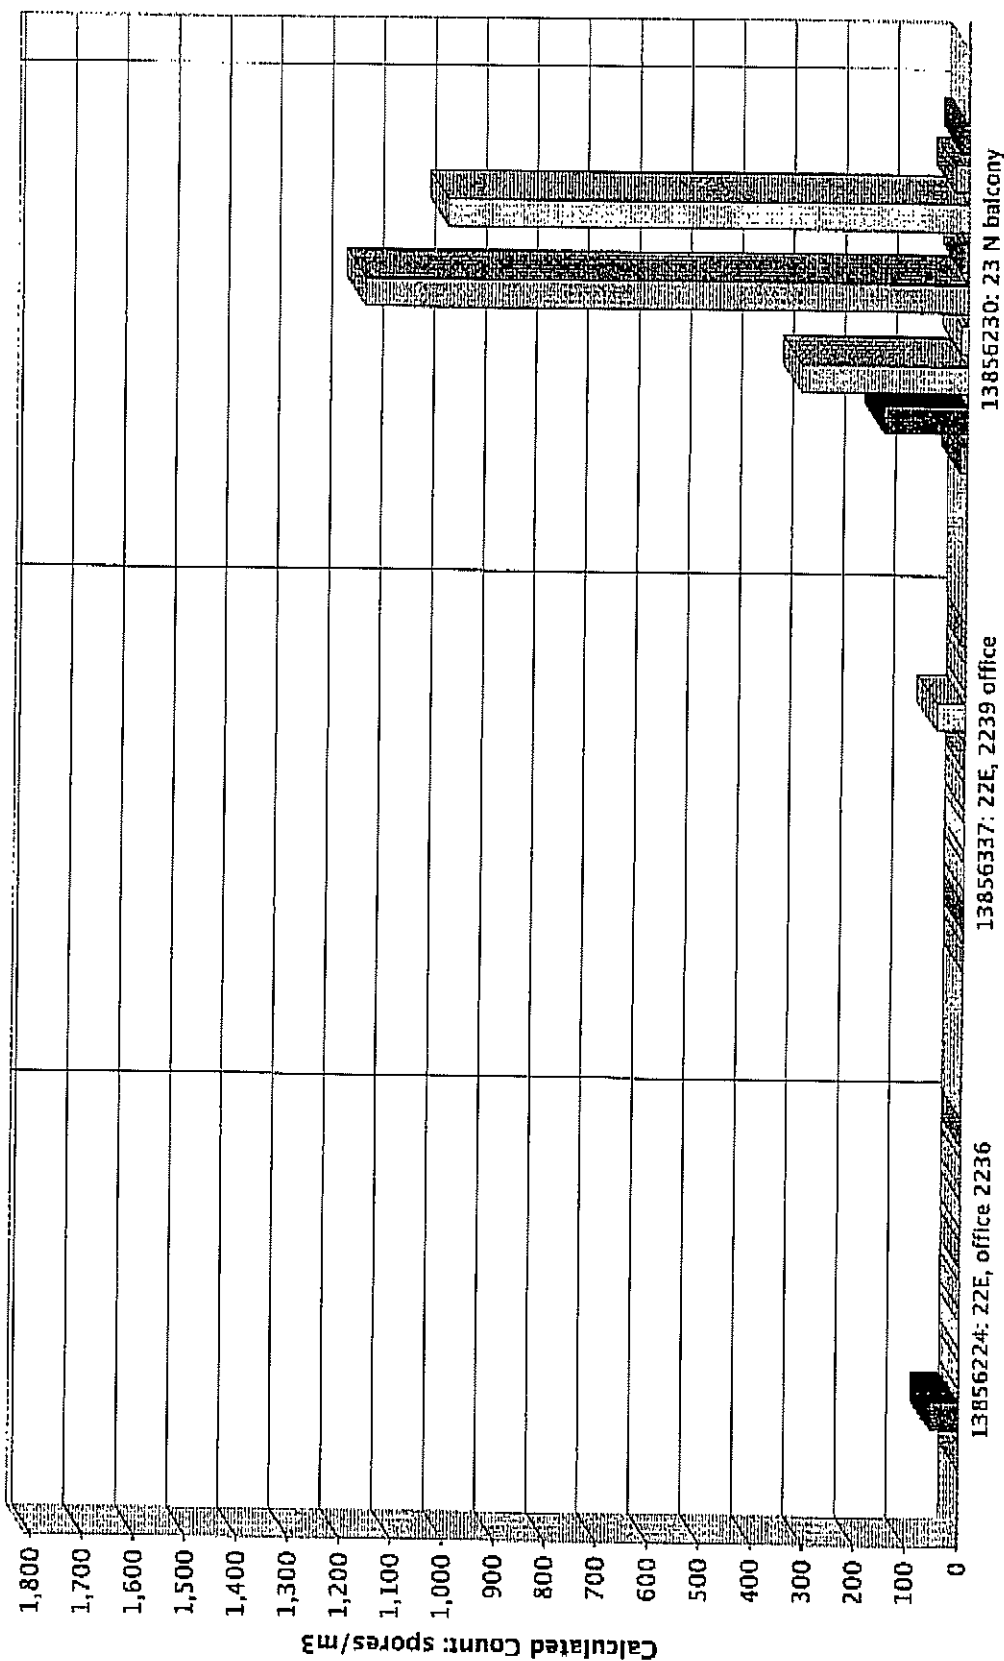
### SPORE TRAP REPORT: NON-VIABLE METHODOLOGY

☒ Alternaria ☒ Ascospores ☒ Basidiospores ☐ Chaetomium ☒ Cladosporium ☐ Other brown ☐ Penicillium/Aspergillus types  
☒ Smuts, Periconia, Myxomycetes ☒ Torula

Note: Graphical output may understate the importance of certain "marker" genera.

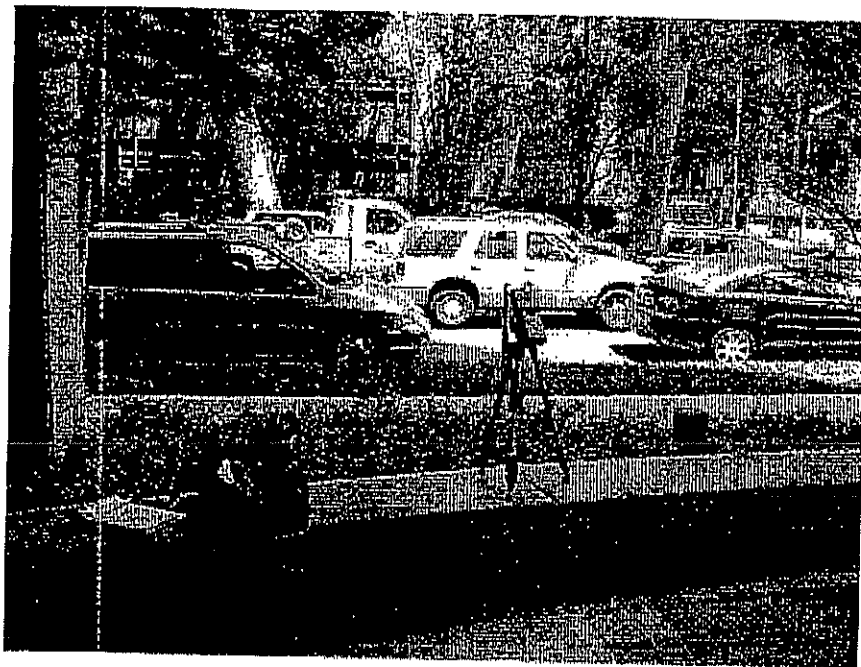
- 1) Image of ambient air sampling location at front entry of BOE Building (Subject Building) located at 450 N Street, Sacramento, California at time of assessment.

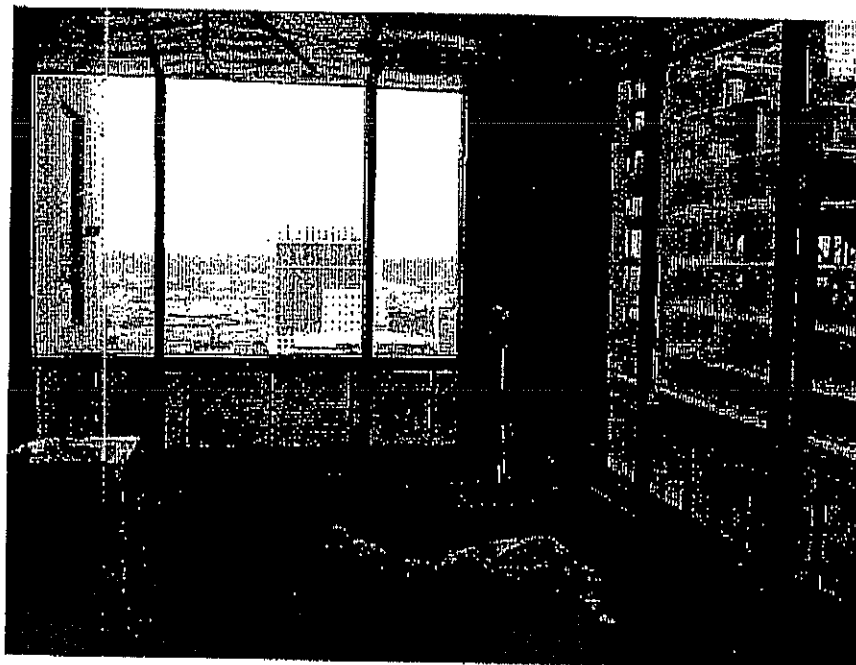
4) Image of air sampling equipment within 22 East containment area at northeastern corner at time of assessment.

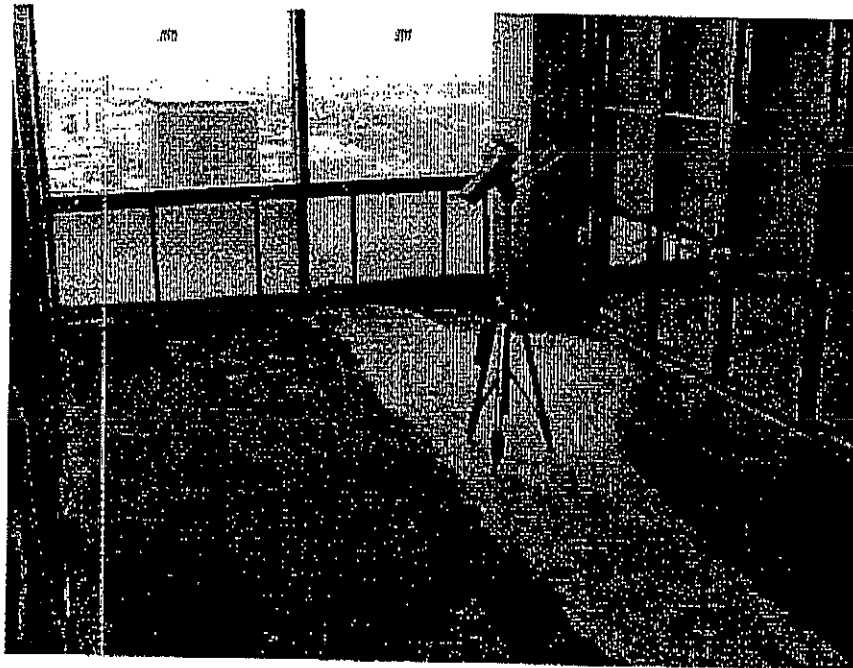
- 6) Additional image of air sampling location within interior of 22 East containment area at time of assessment.

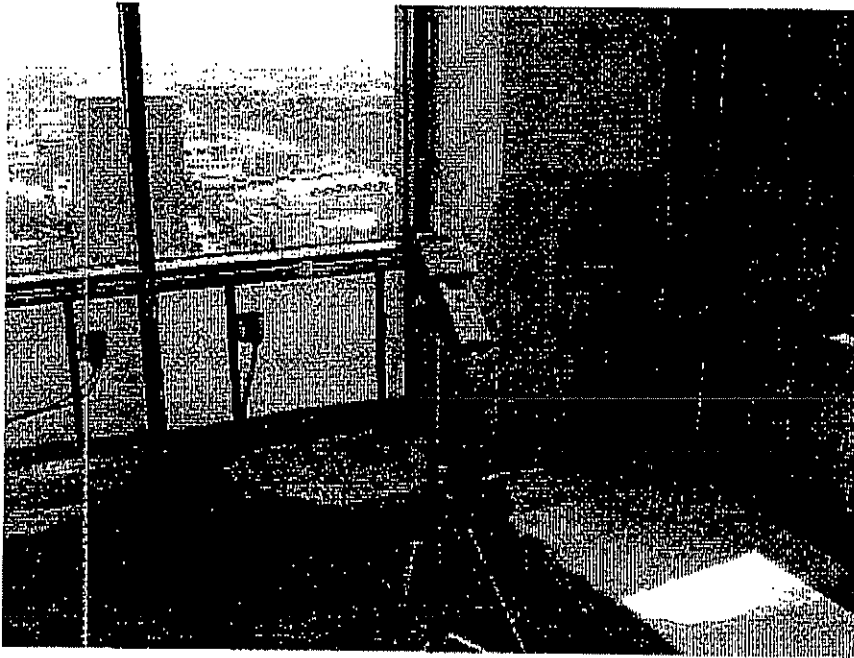
6. As prescribed, all identified affected interior wallboard building materials had been removed from each of the noted areas exposing interior wall cavity framing (metal) and underlayment wallboard siding materials present within the impacted containment areas. Upon post mitigation inspection, all remaining exposed building materials associated with the interior structural and wall systems exhibited no significant staining and/or elevated mold growth following the completion of prescribed physical mold removal and chemical decontamination procedures performed by the selected mitigation contractor on the surfaces of such exposed building materials.

- 7) Close-up image of air sampling equipment and perimeter wallboard removal during clearance assessment within 22 East containment area.

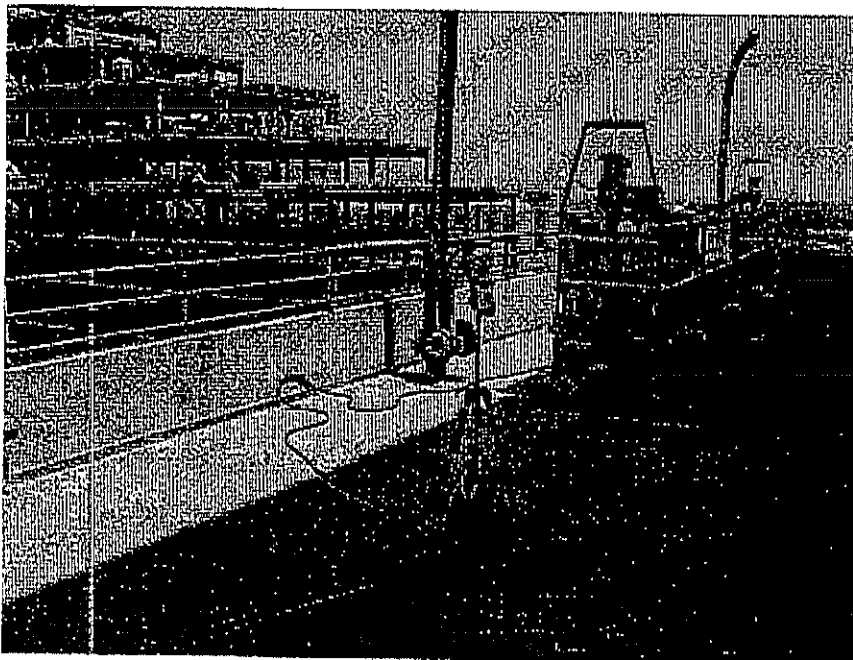
- 8) Image of ambient air sampling equipment located on northern portion of 23<sup>rd</sup> floor area.
